Britt Engineering Associates
Birmingham, Alabama (www.beacom.com)

Technical Note

Subject: 1978 FRP History of Anchors and Supports

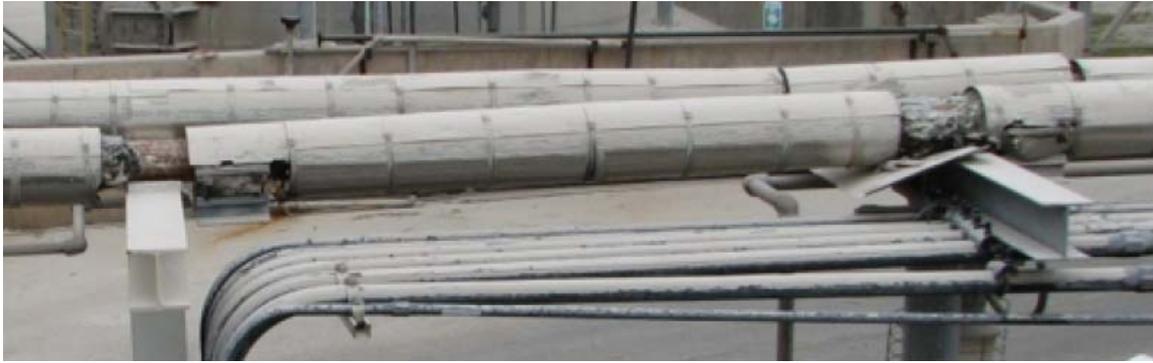
Figure 1. Example of uncontrolled expansion.

1. The anchored system for FRP has been very successful but it is a method that might not be practical for every piping system. However, it is very important to consider using anchors to control excessive expansion. Unrestricted expansion can overstress fittings and joints, move pipe supports off of structural steel, induce high bending stress and can cause other parallel pipes to be overstressed. (See Figures 1-3).

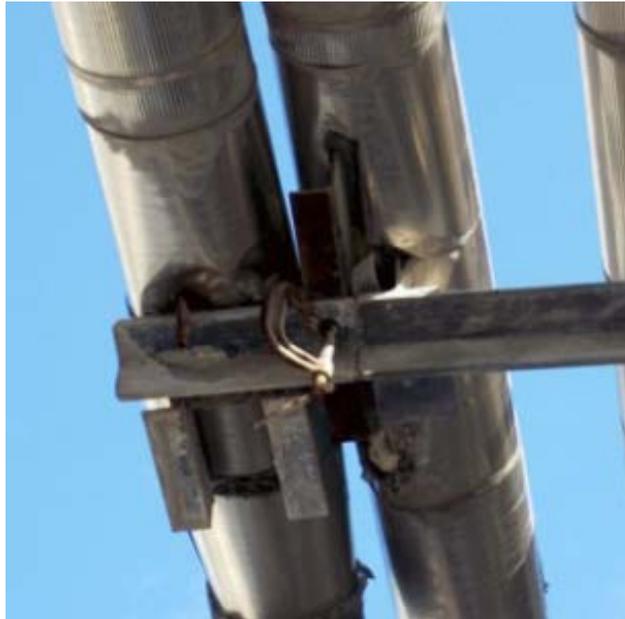
Figure 2. Example of uncontrolled expansion and lack of guides to avoid buckling and lateral movement.

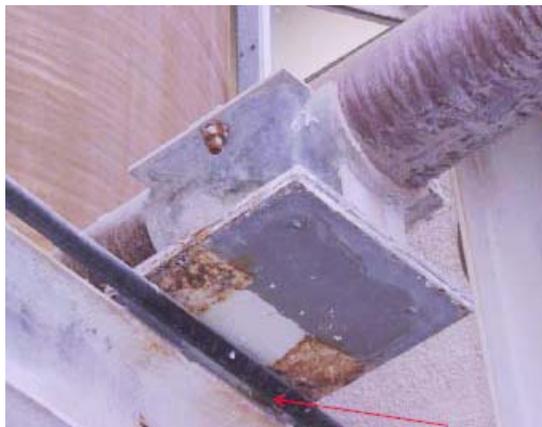
Figure 3. Support at tipping point due to uncontrolled expansion.
